T5-6539-79 END VOLUME \_\_\_\_OF\_\_\_ TITLE METALLURGICAL ANALYSIS OF MBC450-31 HERMETIC ELECTRIC CONNECTOR 🗽 MODEL NO. Saturn V/S-ICONTRACT NO. NASS-5608 129 ACV 25 SUPERVISED BY APPROVED BY APPROVED BY APPROVED BY APPROVED BY

A metallurgical analysis of the spring clips of a MBC 450-31 connector assembly was requested in Additional Analysis Requirements AR 257303 dated September 9, 1966. UER U257303 and UER U262609 reported a failure of current flow in the connector. Analysis found no metallurgical defects. However, contact pins were found to be contaminated with Dow Corning A-4000 an adhesive used to hold a silicon rubber insert in place on the connector.

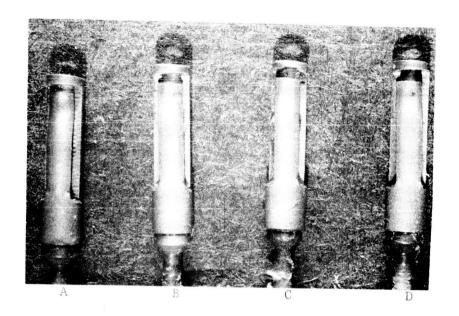
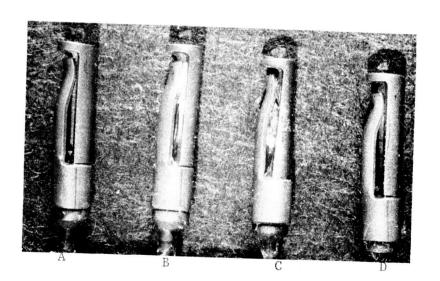
FIGURE 3 CONTACT PINS, 5X

It is concluded that the spring clips were not the cause of poor contact. The four spring clips were found to be of similar material appearing to be an Inconel alloy in a work hardened condition. In the condition the spring clips were found, maximum stiffness and retention can be expected. A possible cause for poor contact could be attributed to an adhesive, Dow Corning A-4000, found inside the contact pins. Excessive amounts were found in pins B and C.

- Examination of the part indicated a foreign substance lodged in the contact pins. Figures 3 and 4 show the pins. Pins B and C show the most contamination. Figure 5 shows the spring clip removed from pin B. The base of the clip was somewhat distorted in disassembly. This foreign material could be the possible cause of poor contact. The spectroscopic analysis, reported in Quality Control Laboratory Test Report LSR 2479, 5-336-M-376, dated October 11, 1966 states that the material, which was found in the contact pins is similar to Dow Corning A-4000, an adhesive which is used to hold a silicon rubber insert in place on the connector.

It is recommended that for Connector Assembly MBC450-31 cleaning and inspection procedures be improved to eliminate the possibility of receiving parts which contain foreign matter.

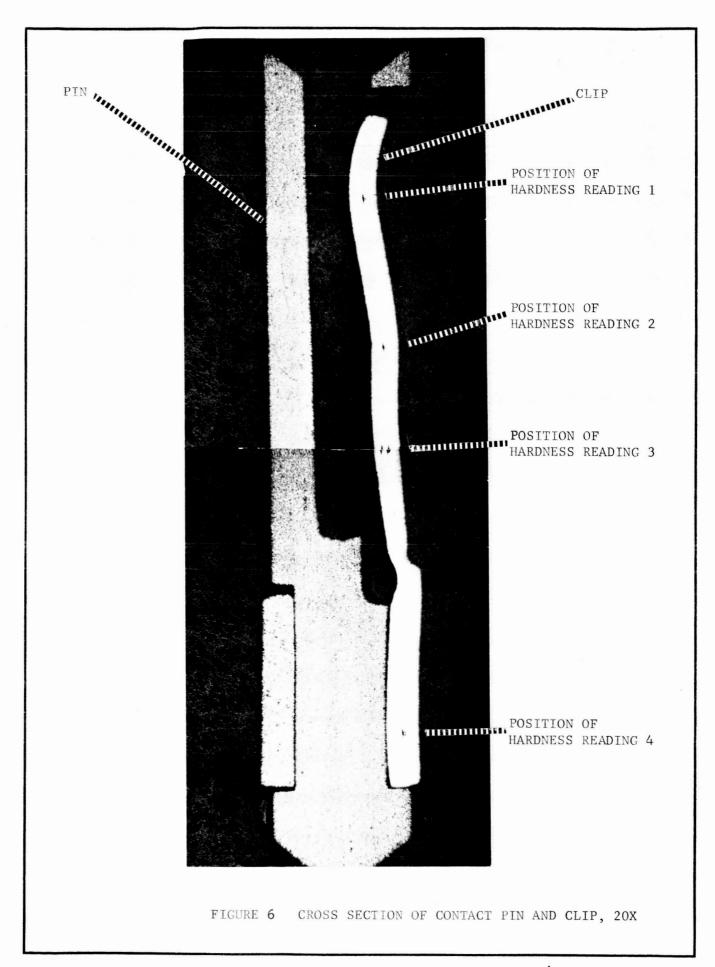
Microhardness readings of the four spring clips indicate a relatively high hardness averaging to about Rockwell C 34.5. This hardness would give a part stiff enough to retain a mating pin. Table I lists the results of the hardness survey performed. The position of each reading is indicated in Figure 6, which is a cross section of an assembled pin and clip. The lower hardness at position 4 indicates a lesser degree of work hardening.

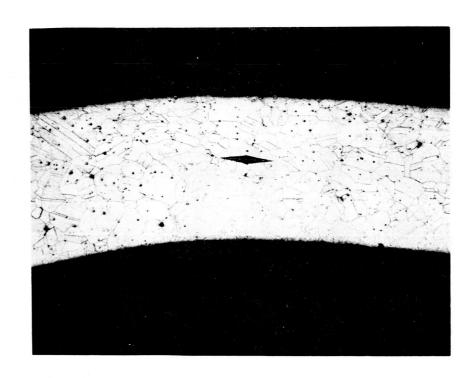
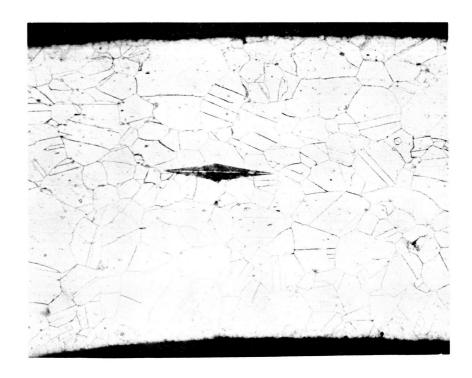
FIGURE 7 - MICROSTRUCTURE OF PIN B

Examination of the microstructure of the four clips revealed they were of similar material. The austenitic matrix characteristic of nickel alloys can be seen in Figure 7, which shows the microstructure of clip B. The alloy has been reported to be an Inconel Alloy. Figure 8, higher power photomicrographs, reveal a highly cold worked structure.

There appears to be no metallurgical defects in the spring clips. Hardness is high enough to assure good retention of mating pins. The probable cause of poor contact is contamination from the application of the insert adhesive.
